| Ref. | DF01947-00 | Date | April 16, 2009 | Page | 1/1 |
| Subject | Client | | McGill Cosmology | # | 13090 |
| | Assem bly # | Cryoelectronics Rev0A | PCB | Cryoelectronics Board Rev0 | |

NPI Non-conformity Report

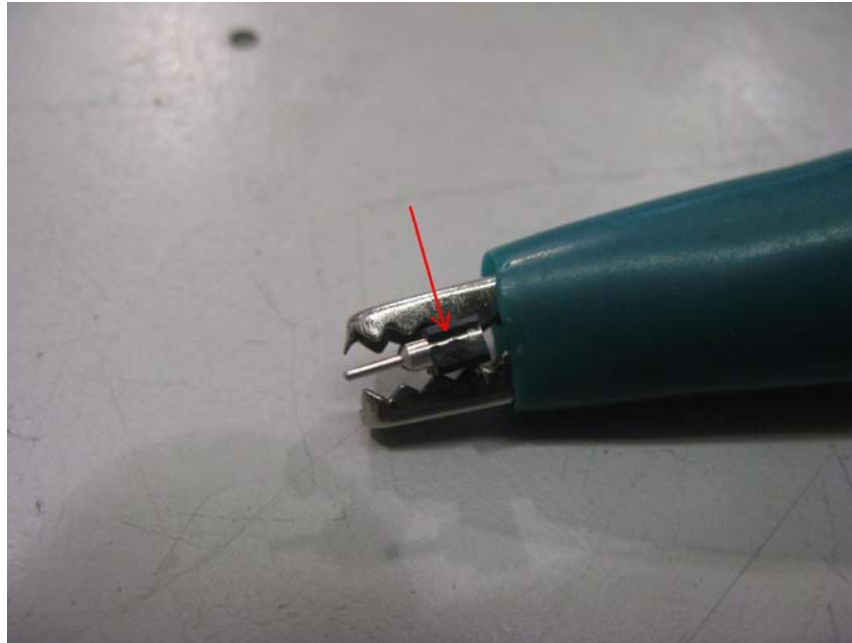
Image 1

- The customer supplied sockets IxJ3 and OxJ1 are not properly cut and the pins are exposed on several pieces, see Image 1. The parts were assembled with customer's agreement, although the result is not IPC-A-610 Class 3 compliant.

| No | Non-conformity | Suggested Solution | Impact | Customer Feedback |
|---|---|---|---|---|
| 5 | Damaged sockets | Review suppliers | Reliability | |

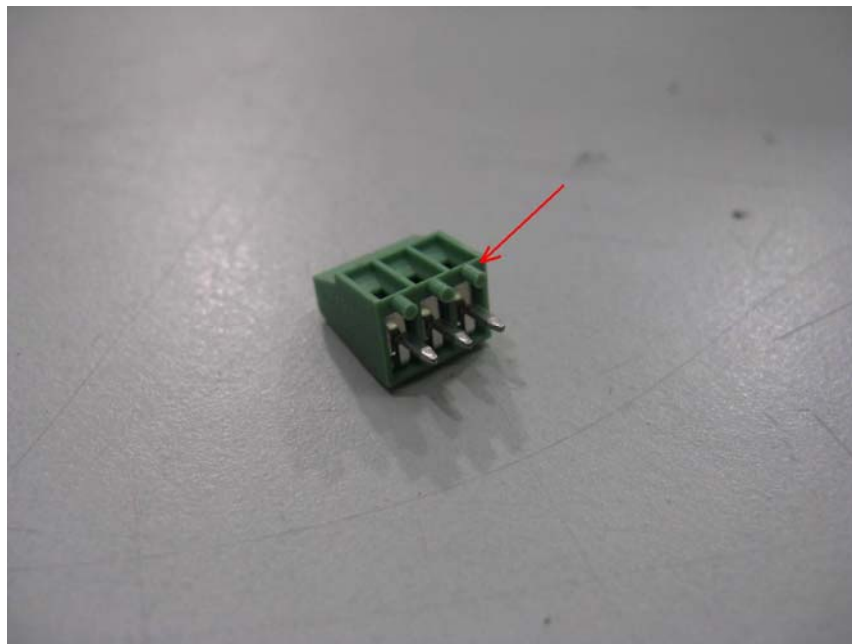
Image 2

6. The terminal blocks J4 and J11 have guiding pins, Image 2, but the PCB does not have holes for those pins. The guiding pins have been removed upon customer's approval.

| No | Non-conformity | Suggested Solution | Impact | Customer Feedback |
|---|---|---|---|---|
| 6 | Mismatch component – footprint J4 & J11 | Review PCB design or component | Productivity | |

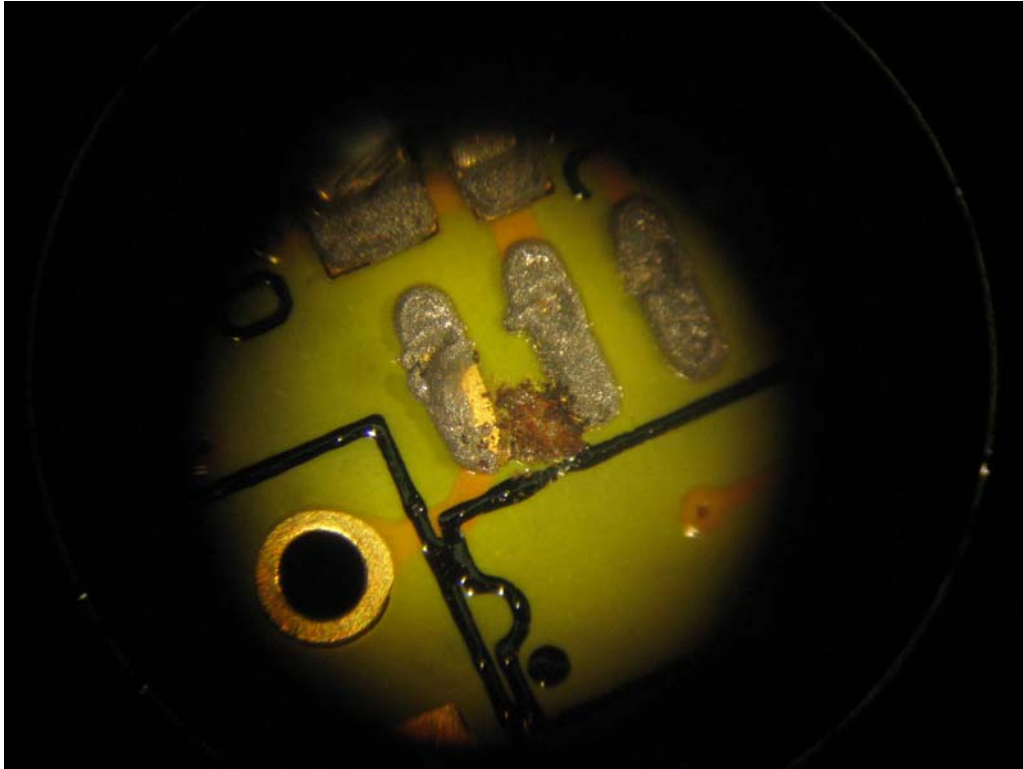
Image 3

7. The yellow solder mask does not allow for proper AOI inspection of the solder joints.
8. One of the PCBs has an imperfection between the pads of O3U4, see Image 3. The solder mask is missing and there is some unknown particulate matter instead. There does not seem to be any circuitry in the affected area and the two pads

are not shorted, so the PCB was populated with customer's agreement. The serial number of the affected product is 14090001.

| No | Non-conformity | Suggested Solution | Impact | Customer Feedback |
|---|---|---|---|---|
| 8 | Solder mask issue on one PCB | Notify supplier | Reliability | |
